**NASA TECHNICAL
MEMORANDUM**

**EVALUATION OF WELDING TECHNIQUES FOR
TUNGSTEN - URANIUM DIOXIDE COMPOSITES**

by Thomas J. Moore and Gordon K. Watson

Lewis Research Center

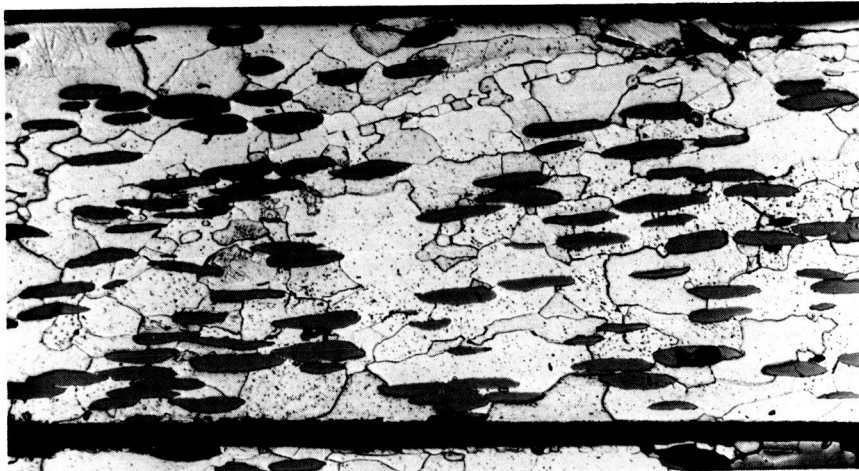
Figure 15. - Cross section from vacuum hot-press bonded small butt joints at location indicated. Etchant, Murakami's reagent. Magnification, X100.

(a) Specimen 39. Joint classification, poor. Nonbonded region due to insufficient plastic flow.

(b) Specimen 44. Joint classification, fair. Note edge crumbling.

(c) Specimen 51A, insert-type joint. Joint classification, good.

(d) Specimen 48, insert-type joint. Joint classification, excellent.

The results of the bend tests, including sketches illustrating the location of failures, are presented in table VII. All the samples failed during the bend test at both temperatures, but metallographic examination of the fractures indicated that in all cases the fracture did not follow the bond line. Although no real evaluation of bond quality could be determined, these results indicate that the bonding time-temperature cycle and/or a contamination problem (which will be discussed in the section Contamination problems) resulted in an increase in the transition temperature of the W-UO₂ base material because the untreated base material can be easily bent at temperatures as low as 400° C. The edge crumbling condition observed in figure 15(b) also could have contributed to the poor bend ductility.

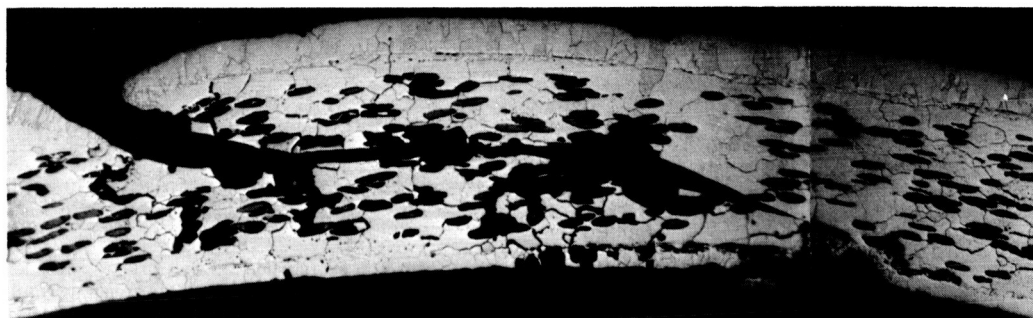
Figure 17. - Poorly bonded and defective joints in tungsten - uranium dioxide cylinders joined by vacuum hot-pressing. Joints from locations indicated. Etchant, Murakami's reagent. Magnification, X50.

(a) Cross section of cylinder butt joint (specimen F) with little grain growth across interface. Joint classification, poor.

(b) Cross section of cylinder butt joint (specimen I) showing separated joint and uranium dioxide loss at interface.

(c) Cross section of cylinder butt joint (specimen R) showing excessive plastic flow and loss of material at joint. Tantalum carbide contamination on outside diameter.

The most common flaw detected in the other specimens was the lack of grain growth across the interface. A typical flaw of this type is shown in the photomicrograph in figure 17(a). Other types of more severe joint defects are shown in figure 17(b) and (c). The joint shown in figure 17(b) is not intact which has resulted in an extensive loss of UO₂. Excessive plastic flow occurred in the specimen shown in figure 17(c), and gross defects resulted.

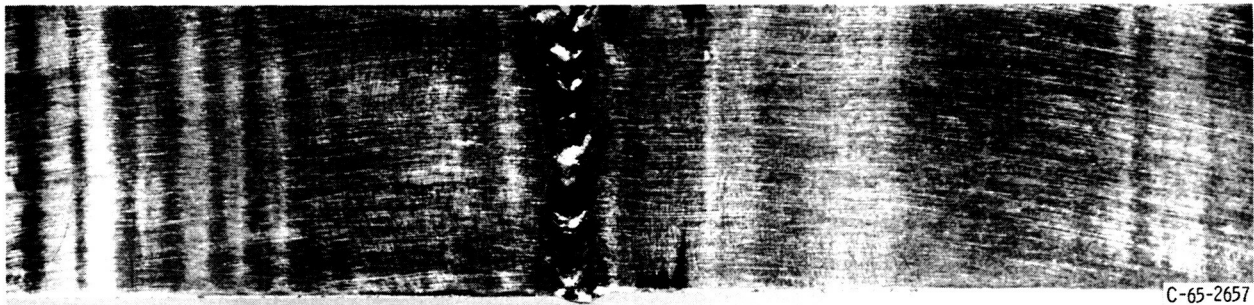
Figure 23. - Tensile blank specimen 356 gas tungsten-arc brazed with tungsten - 25-percent osmium alloy. Arc-start and runoff tabs (shown in fig. 6) have been removed.

Face (top)

Root (bottom)

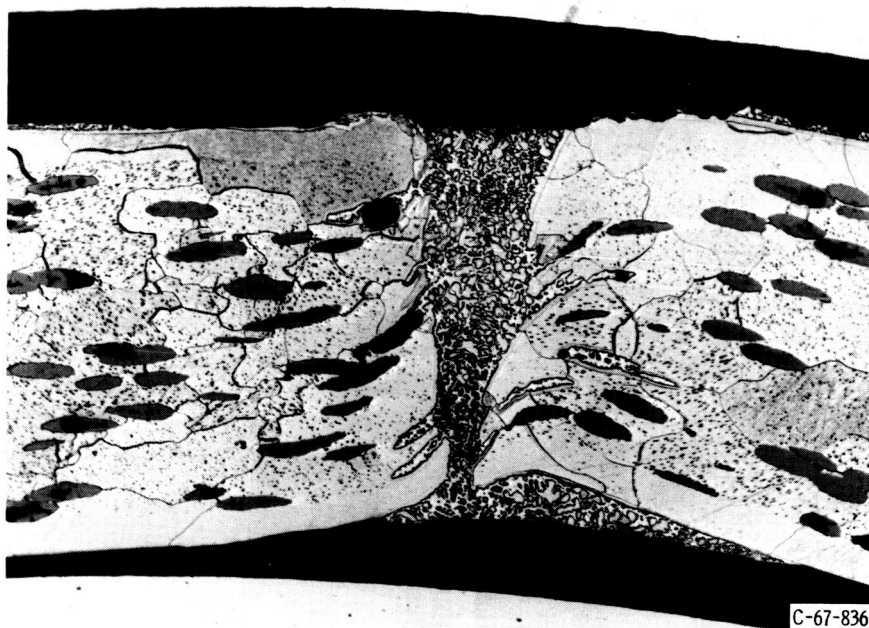
Figure 27. - Cross section of excellent as-brazed joint in tungsten-uranium dioxide cylinder using tungsten - 25-percent osmium alloy. Loss of uranium dioxide (black areas) is believed to have occurred during metallographic preparation. Etchant, Murakami's reagent. Magnification, X100.
